Evaluation Report 306

Willcar Autotran 2500 Pull-Type Windrower

Willcar Autotran 2500 Pull-type Windrower

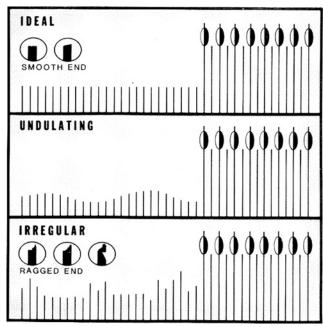
FIGURE 1. Types of Stubble.

Stubble: Stubble was usually slightly irregular (FIGURE 1). Ideal stubble was produced only in clean, ripe crops. Poor table flotation caused undulating stubble in rough fields.

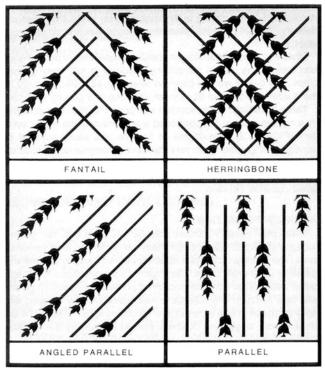
FIGURE 3. Windrow Types.

Windrow Types: Windrows may be classified into four general patterns (FIGURE 3), athough many combinations and variations exist. The Autotran 2500 produced parallel and angled parallel windrows in most grain crops. Herringbone windrows occurred in light crops while fantail windrows occurred primarily in heavy crops and wild oats patches. The adjustable reel speed allowed for good windrow formation over a wide range of ground speeds. FIGURES 4 to 9 show typical single and double windrows formed by the Autotran 2500

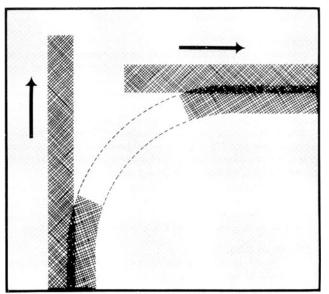
FIGURE 10. Typical Corner Formation.

In overshoot delivery, the drapers could be shut off on corners to form a double windrow which was easily picked up. FIGURE 10 shows a typical corner formation. The dotted line shows the path the second windrow would follow if the drapers were not shut off.
